Subject: EPA Inspection Report - Family Farm

CWA COMPLIANCE EVALUATION INSPECTION REPORT U.S. ENVIRONMENTAL PROTECTION AGENCY, REGION 5

Purpose: Compliance Evaluation Inspection

Family Farm – Photo Log Attachment A

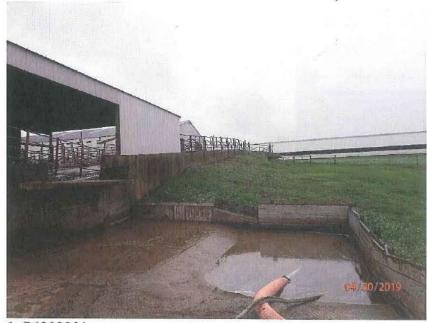
1: P4300001

The Solids Separation Basin is not water-tight. An open section at the southeast corner of the basin has screening to hold back solids but allows process wastewater to flow to the south and down a channel in the front yard to East Welch Road. A culvert under East Welch Road conveys the flow to the south and to a hillside. The flow continues through a channelized waterway to the south until the slope of the hillside decreases. The flow then spreads out and diminishes in the vegetation until there is no additional flow down the hillside.

Description: Solids separation happens in the Solids Separation Basin south of the Holding Area. Process wastewater flows out of the basin at the southeast corner and down the front yard. Liquid is also pumped out of the basin to a tanker truck which moves it to the Earthen Storage Structure.

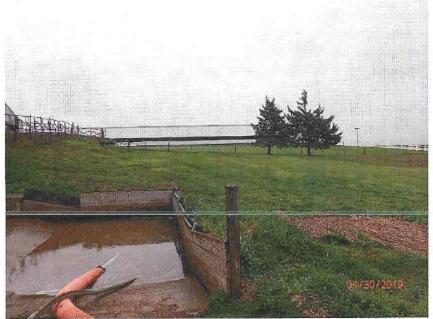
Description: Solids separation happens in the Solids Separation Basin south of the Holding Area. Process wastewater flows out of the basin at the southeast corner and down the front yard.

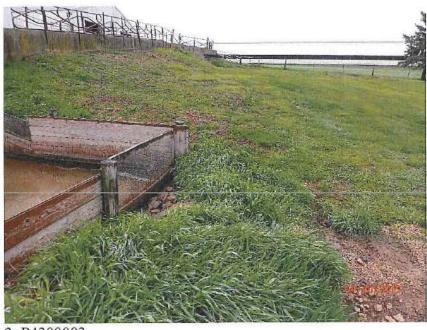
3: P4300003

Description: Process wastewater flows out of the Solids Separation Basin at the southeast corner and down the front yard.

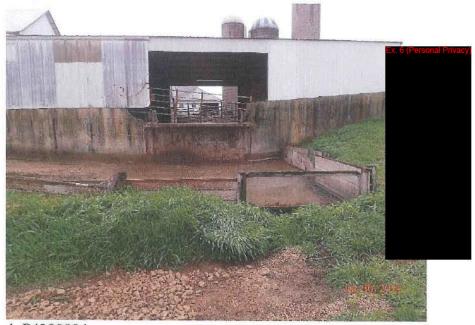
Description: Solids Separation Basin south of the Holding Area.

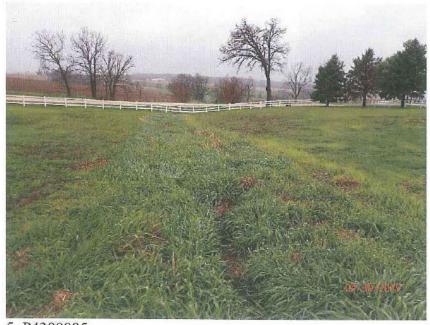
5: P4300005

Description: Process wastewater flows in a channel down the front yard to the south.

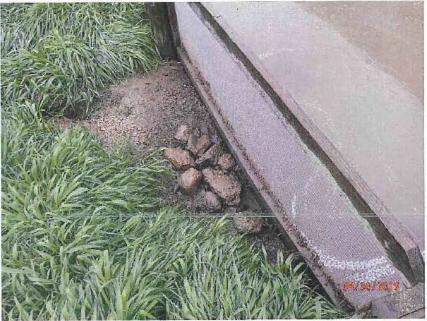
6. P4300006

Description: Rocks in the channel outside the screen at the southeast corner of the Solids Separation Basin.

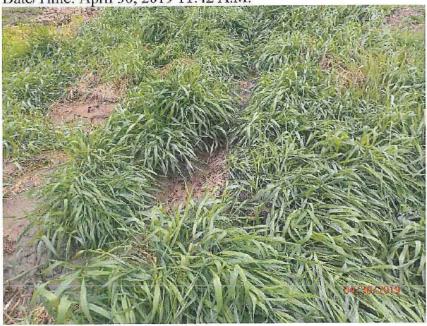
7: P4300007

Description: The channel in the front yard has manure solids in it from the process wastewater that flowed out

of the Solids Separation Basin.

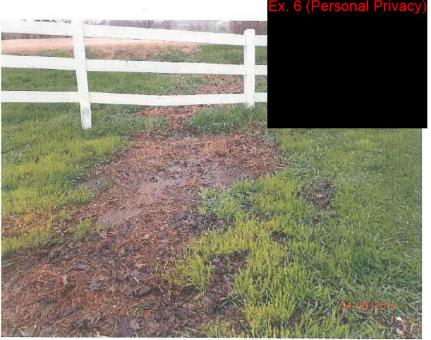
Description: The channel in the front yard continues to the fenceline north of East Welch Road.

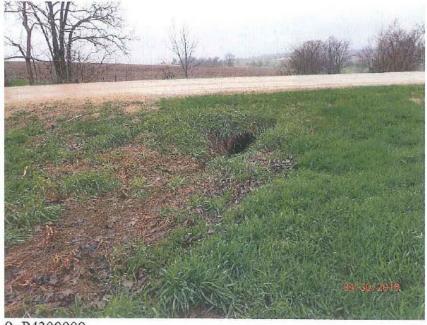
9: P4300009

Description: Process wastewater flows down the front yard and to a culvert pipe under East Welch Road.

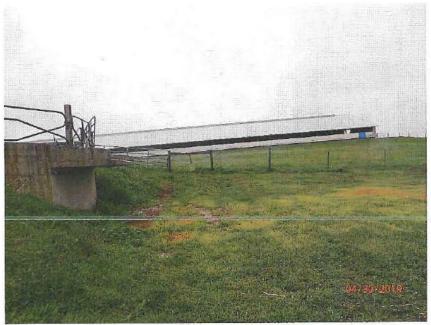
EPA then walked back north to the Cattle Walkway and observed a push off ramp on the Cattle Walkway. EPA observed that there was no containment for manure and process wastewater from the push off ramp. A channel in the yard below the ramp indicated that flow off the push off ramp would join with the flow from the Solids Separation Basin and flow south down the channel in the front yard.

Description: Push off ramp on the south side of the Cattle Walkway. There is no containment for manure and process wastewater from the ramp and to the yard below.

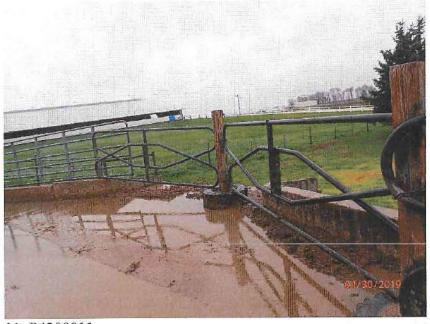
11: P4300011

Description: There is no containment for manure and process wastewater from the push off ramp and to the yard below.

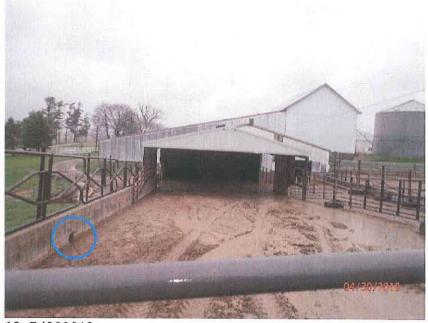
Description: Looking toward the Holding Area from the Cattle Walkway. EPA observed a weep hole in the

concrete wall of the Cattle Walkway (blue circle).

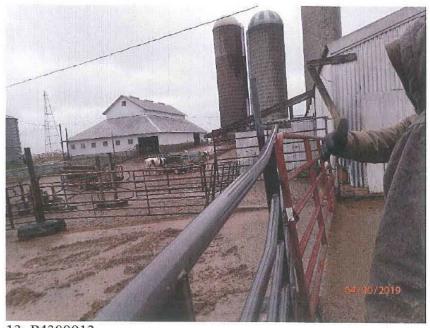
13: P4300013

Description: Open Feedlot north of the Holding Area is sloped to the south toward the Holding Area.

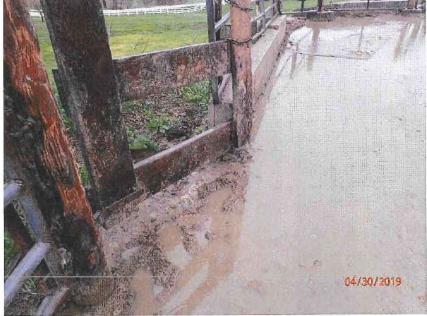
15: P4300015

Description: EPA observed manure and process wastewater flowing under the fencing and off the Cattle

Walkway to the yard below. Location: Cattle Walkway.

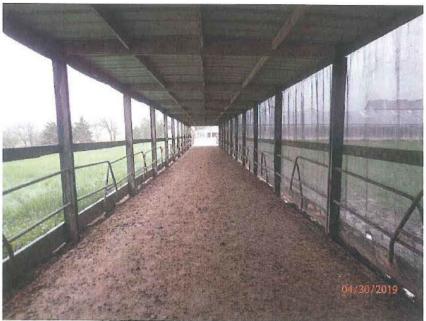
Description: Inside the Cattle Walkway. EPA observed that there was no containment to prevent manure and process wastewater from leaving the Cattle Walkway under the side boards.

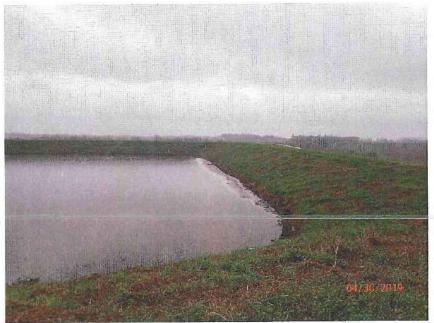
Description: There was over six feet of freeboard in the Earthen Storage Structure on the day of the inspection.

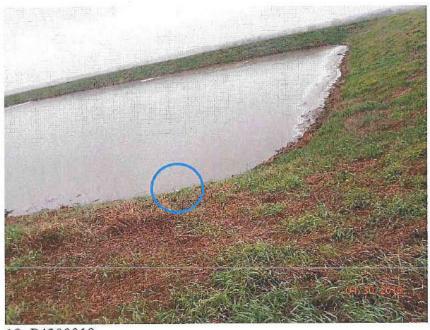
19: P4300019

Description: Vegetation was mowed and EPA did not observe any rodent holes or woody growth on the berm of the Earthen Storage Structure. Pipe from the reception pit east of the Freestall Barn outlets in the southeast corner of the Earthen Storage Structure (denoted by a blue circle).

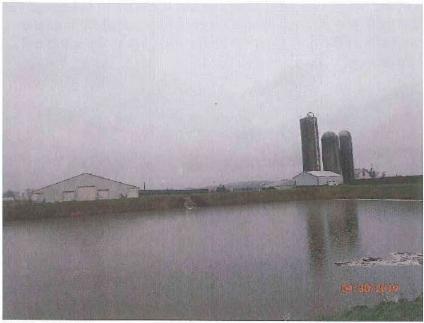
Description: Displaced dirt area on berm of Earthen Storage Structure is where tanker trucks access the storage structure to pump the manure and process wastewater.

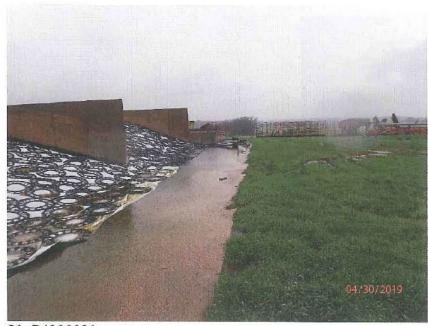
21: P4300021

Description: Silage is kept covered and away from the north edge of the Silage Pad. Open face of the silage is on the south side.

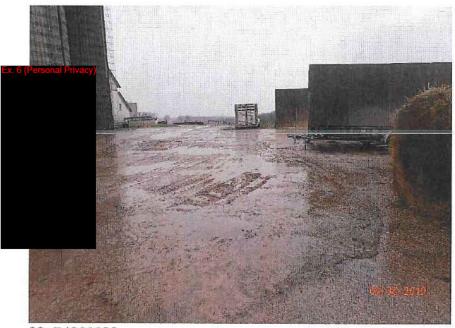
22: P4300022

Description: The open ends of the silage are in the bays to the right in the photo. Flow off the Silage Pad is to the south or west.

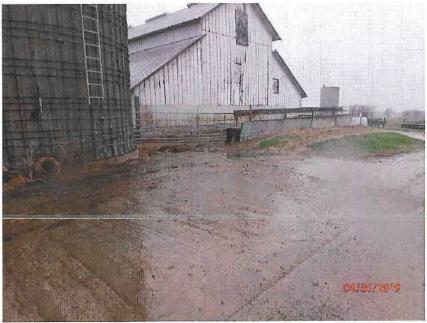
Description: EPA observed process wastewater north of the silos flowing with precipitation to the south and

through the Open Feedlot north of the Holding Area.

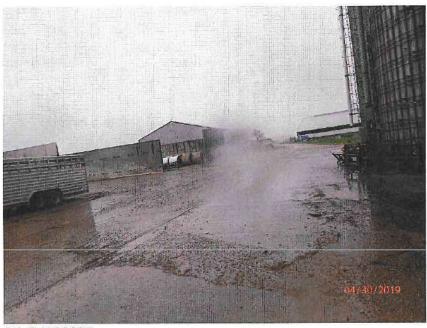
27: P4300027

Description: EPA observed process wastewater from the silage flowing with precipitation to the west and south and then through the Open Feedlot north of the Holding Area.

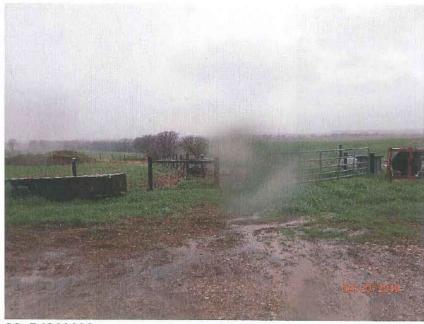
29: P4300029

Description: Some flow off the Silage Pad flows to the west and to the hillside. EPA did not observe any flow reaching a water of the U.S. from process wastewater from the Silage Pad.

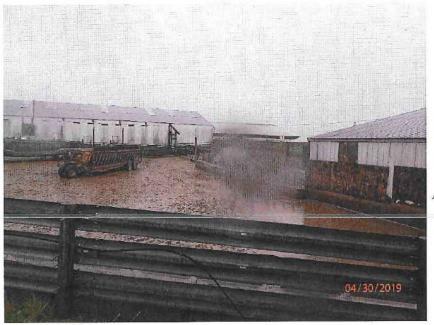
Description: The facility created a Settling Basin that captures much of the flow off the Open Feedlot north of of the Holding Area. The facility personnel open the hole in the wall of the Holding Area wall and the flow goes through the Holding Area and to the Solids Separation Basin. When the flow reaches the Solids Separation Basin, a pump is utilized to move this water to a tanker truck and then to the Earthen Storage Structure.

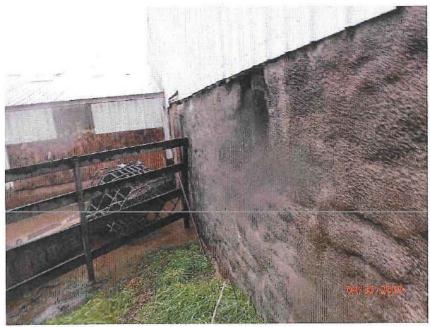
31: P4300031

Description: The facility created a dam on the north side of the Holding Area to capture precipitation flowing from the north by blocking a hole in the wall of the Holding Area. Facility personnel call this area the Settling Basin.

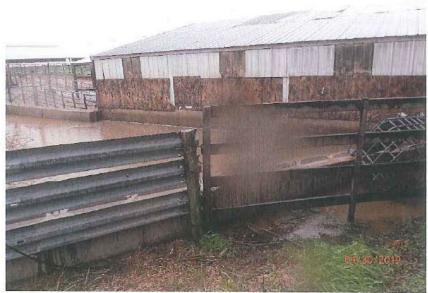
Description: Water that flows south through the Open Feedlot north of the Holding Area is held until the facility is ready to pump it to the Earthen Storage Structure. They release the water and it flows through the Holding Area and to the Solids Separation Basin south of the Holding Area. A pump in that basin pumps the flow to a tanker truck which then transports the manure and process wastewater to the Earthen Storage Structure.

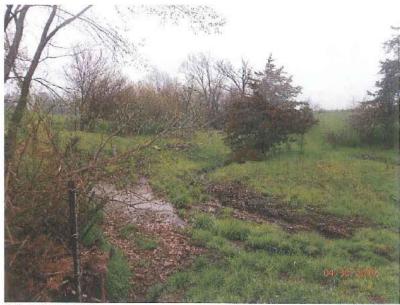
36: P4300036

Description: The flow from the facility continues down a hillside on the south side of East Welch Road. An intermittent unnamed tributary at the bottom of the hillside is approximately 0.43 miles away. EPA walked down to the bottom of the hillside and observed the intermittent tributary. Photo is looking upstream at the intermittent unnamed tributary.

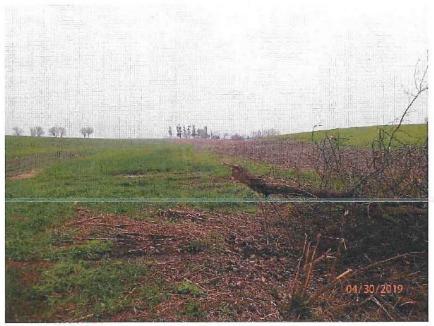
Description: At the bottom, the slope of the hillside flattens out and EPA could not distinguish a continuous pathway or channel from the flow at the top of the hillside.

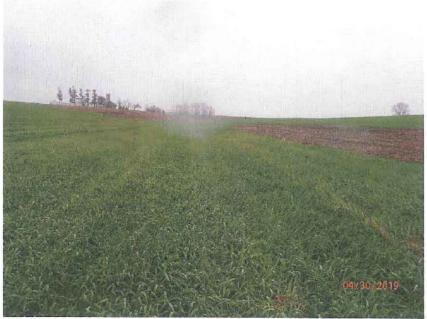
Description: Continuing to walk back north up the hillside, EPA did not observe any channelization or

vegetation that appeared nutrient burned from the flow from the facility.

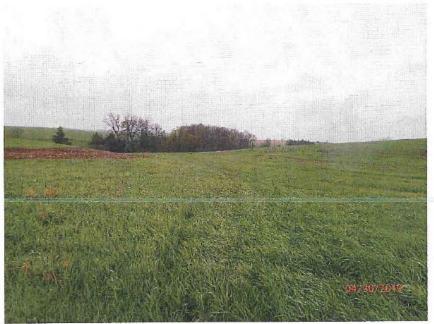
Description: Looking back toward the intermittent unnamed tributary at the bottom of the hillside (in the treeline). EPA did not observe any channelization or vegetation that appeared nutrient burned once the slope of the hillside decreased. In the flattest part of the hillside, approximately 0.25 miles from the facility, EPA did not observe standing water below the vegetation.

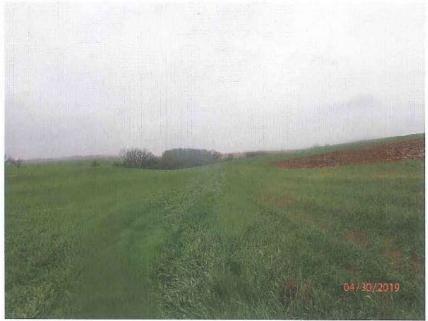
Description: Looking back toward the intermittent unnamed tributary from the hillside. EPA did not observe channelization of flow in the hillside once the slope decreased.

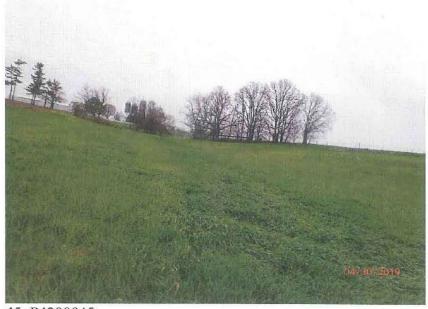
45: P4300045

Description: Looking up the hillside from approximately 0.25 miles from the facility. At this location, EPA observed water under the grasses, but the water was spread out and shallow. The vegetation did not appear nutrient burned.

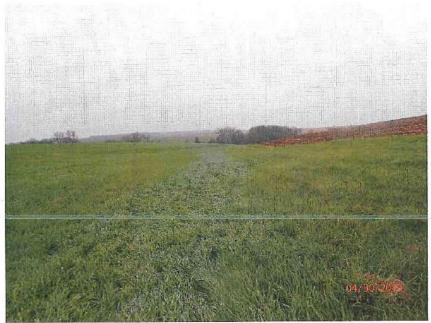
Description: Looking down the hillside from approximately 0.25 miles from the facility. At this location, EPA observed water under the grasses, but the water was spread out and shallow. The vegetation did not appear nutrient burned.

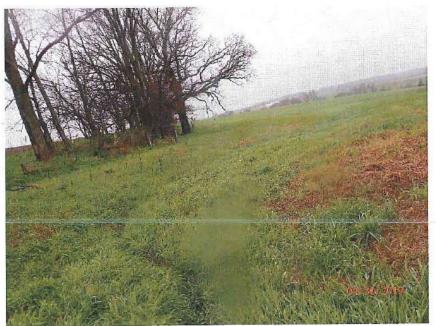
Description: Looking south from the same location as photo #49. EPA observed the channel of flow from the north to the south.
